## ANTENNA MAST COLLAPSE ANALYSIS

**Abstract:** In long-term usage of the steel antenna, masts corrosive processes occur that are especially manifested at the welded joints and joints with bolts. Combined with the irregular renewal of the anticorrosive protection these processes may become a dominant cause for disaster, especially at the sections where critical tensions stresses occur. These

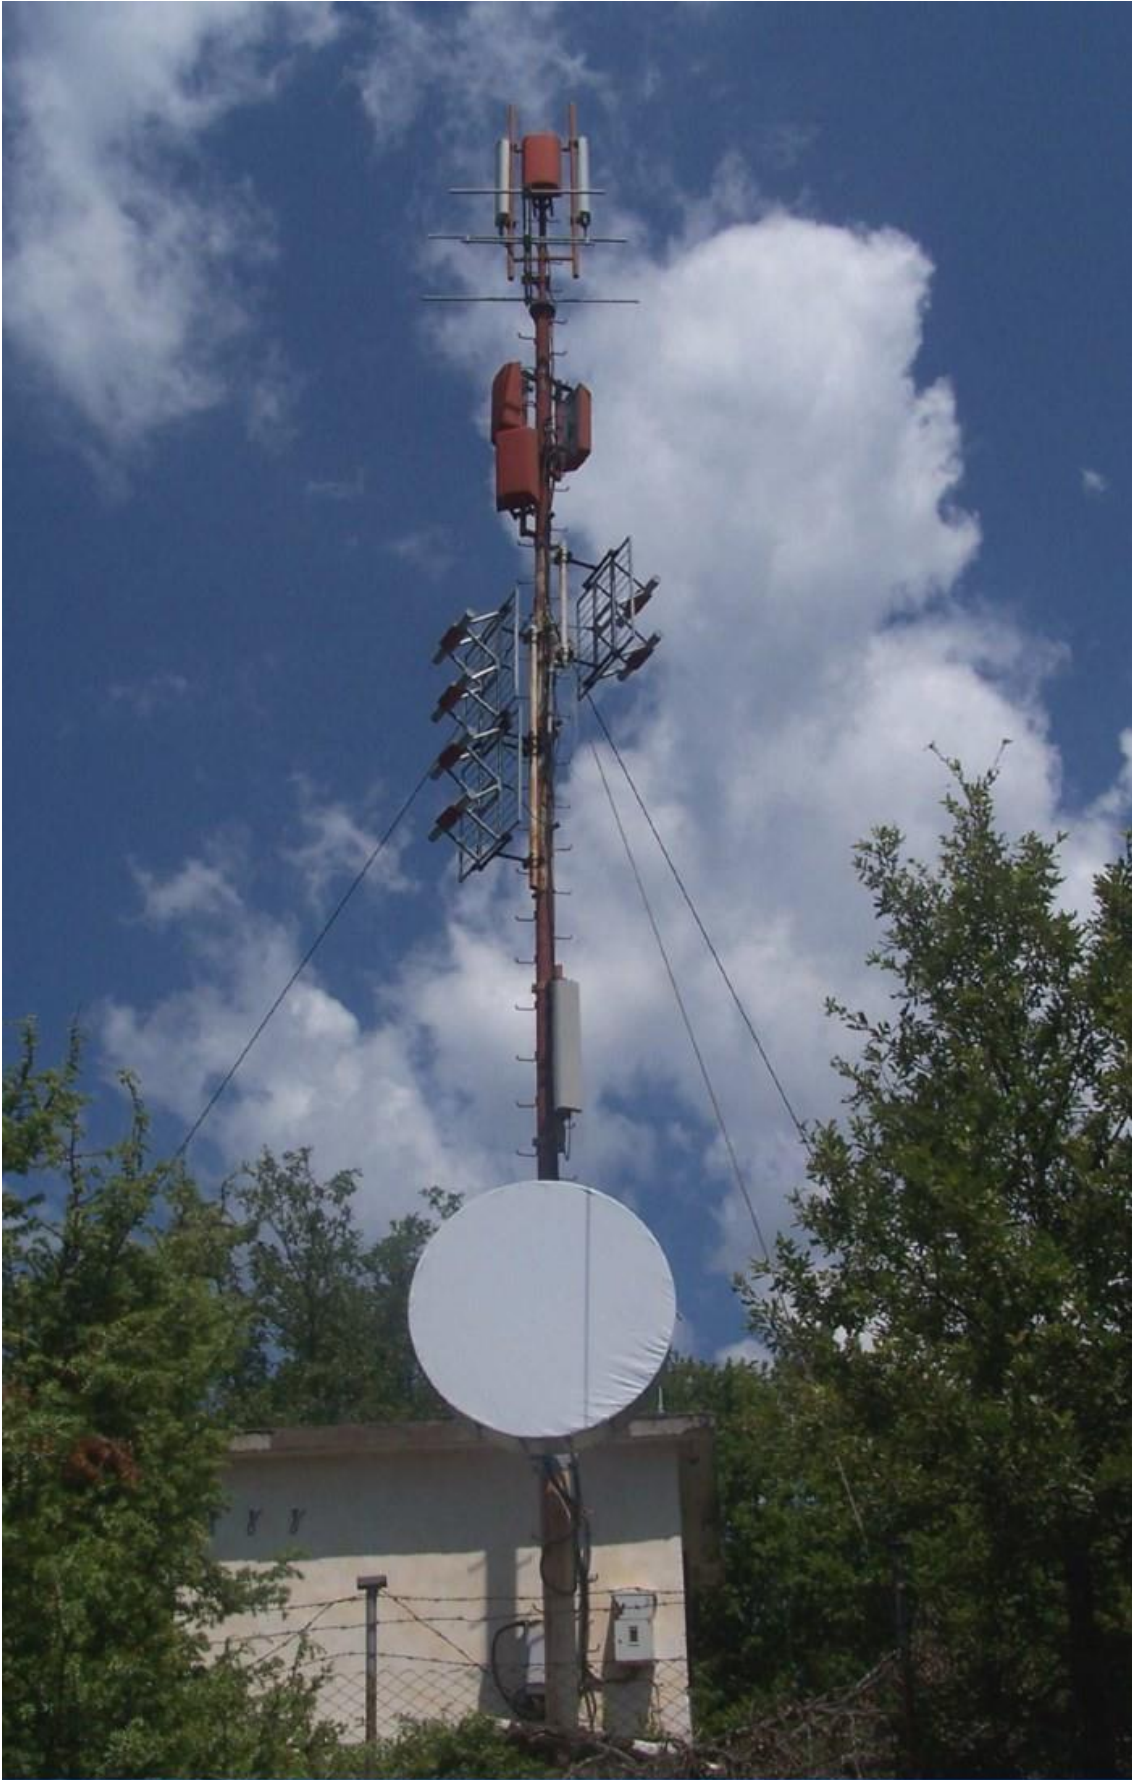
**Fig. 1.** Outline of the antenna mast before the disaster

The total height of the mast is 19.5 m. The mast is composed of four segments with diameters:  $\text{Ø}273$ ,  $\text{Ø}168$ ,  $\text{Ø}168$ ,  $\text{Ø}88.9$  mm, and heights of 4.5, 6.0, 6.0 and 3.0 meters respectively. The mast is additionally fastened with three guys. The point of fastening of the guys is at height of 12.5 meters.

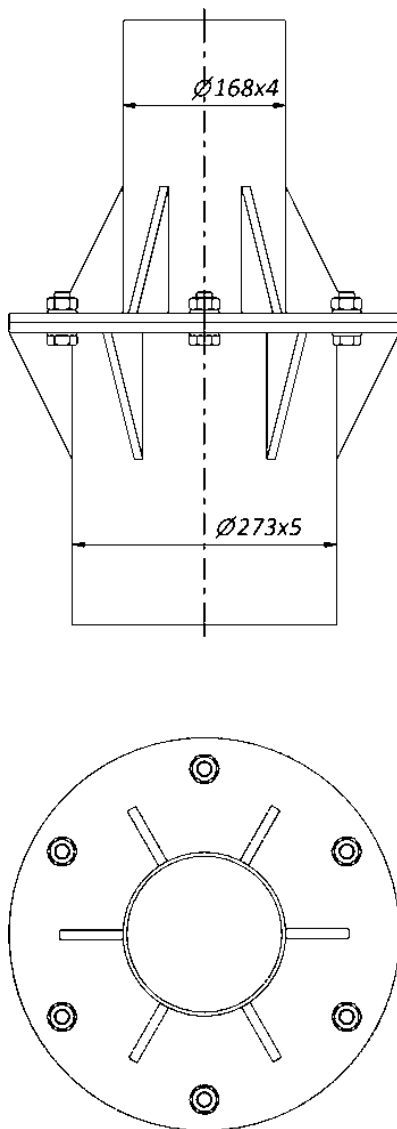
On Figure 2 is shown the joint between the first and the second segment of the mast. The first segment of the mast is a tube with diameter of  $\text{Ø}273$  mm and wall thickness of 5.0 mm. The second segment is a tube with diameter of  $\text{Ø}168.3$  mm and thickness of the wall of 4.0 mm. The first and second segments of the mast are connected with flanges having diameter of  $\text{Ø}403$  mm and wall thickness of 10 mm. The joint between the first and second segment is of dismantling type using 6 M16 bolts (Figure 2).

Fig. 2. The joint between the first and second segment

The transition of the mast between the segment number 1 to segment number 2 is made with big difference between the sections of the steel tubes (Figure 2). Namely, the first segment has diameter of  $\text{Ø}273$  mm and wall thickness of 5.0 mm, while the second segment is a tube with diameter of  $\text{Ø}168.3$  mm and wall thickness of 4.0 mm.

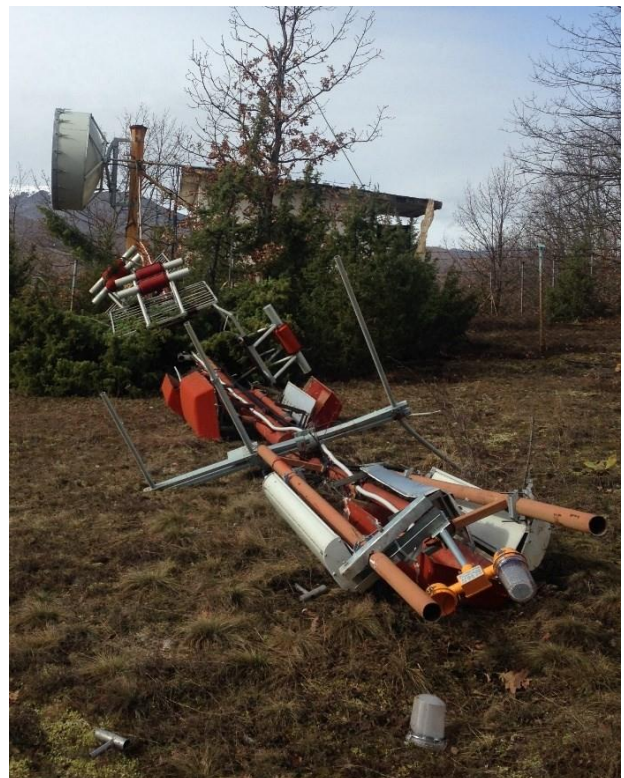
Fig. 3. Photo of the fallen mast segments

Figure 3 shows the state of the mast after the fall of the second, third and the fourth segment. The calculated bending moment at the cross-section where the break occurred in the worst case of load is  $M = 6.5$  kNm [1].

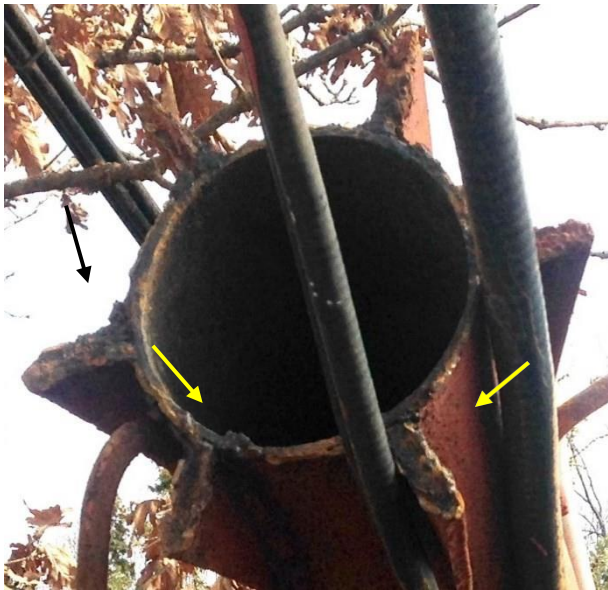
The critical section of the mast where the breaking happened, the welded joint was long time

exposed to corrosion (Figure 4). The mast is in use since 1987, which is a time frame of 30 years.

The processes of corrosion in this case are the dominant causes of weakening of the cross section of the welded joint. On Figure 4 torn welded connections can be seen. That could not withstand the loads acting on the mast in the moment of the disaster. Likewise, at the breaking section evident are insufficient weld connections.

Fig. 4. The critical section at the welded joint

To avoid these events, regular checks and maintenance of the antenna masts are mandatory by qualified teams.

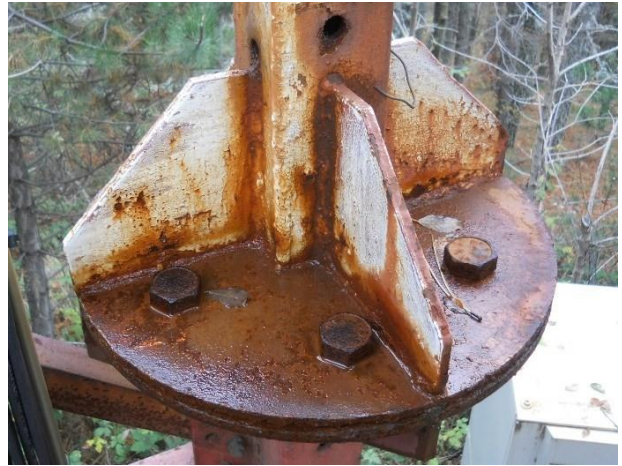
On Figure 5 evident is mature phase of corrosion due to many years of not maintaining the anticorrosive protection. Corrosion in this case is especially dangerous at the welded joints.

Fig. 5. Corrosion of the connecting flange

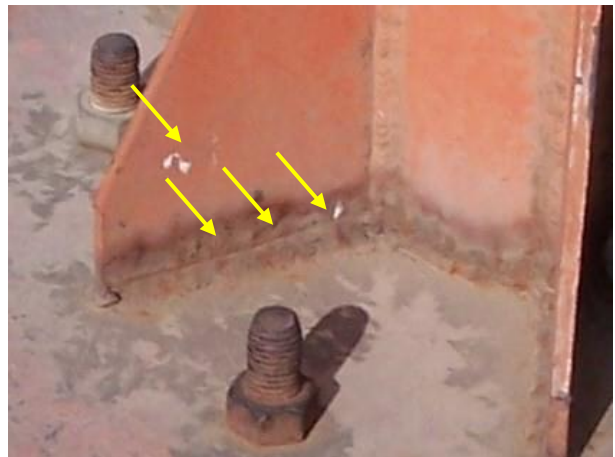
Fig. 6. Tensile stress crack caused by corrosion

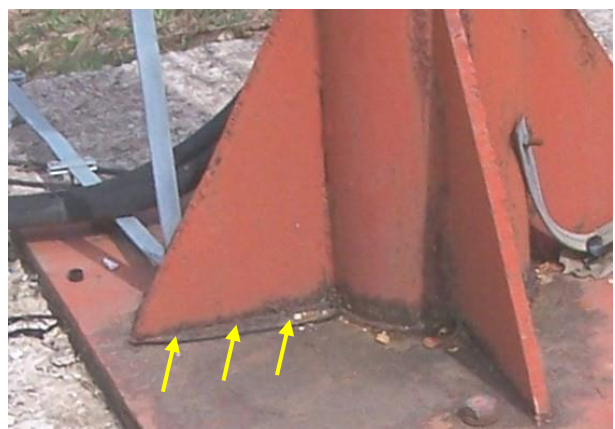
Fig. 7. Tensile crack caused by corrosion

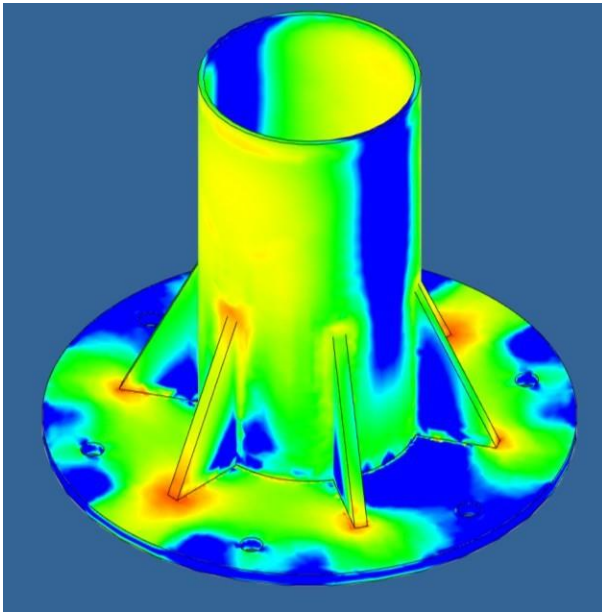
This condition in combination with the tension state shown on Figure 8 clearly points that development of the cracks in the welded joints started at the

locations with the highest concentration of tensions stresses.

Fig. 8. Computer simulation of the tension stress state at the critical section of the mast
